# Site Visit Report and Recommendations Related to Sagging Floor

Jonathan Fisher House  
Blue Hill, ME

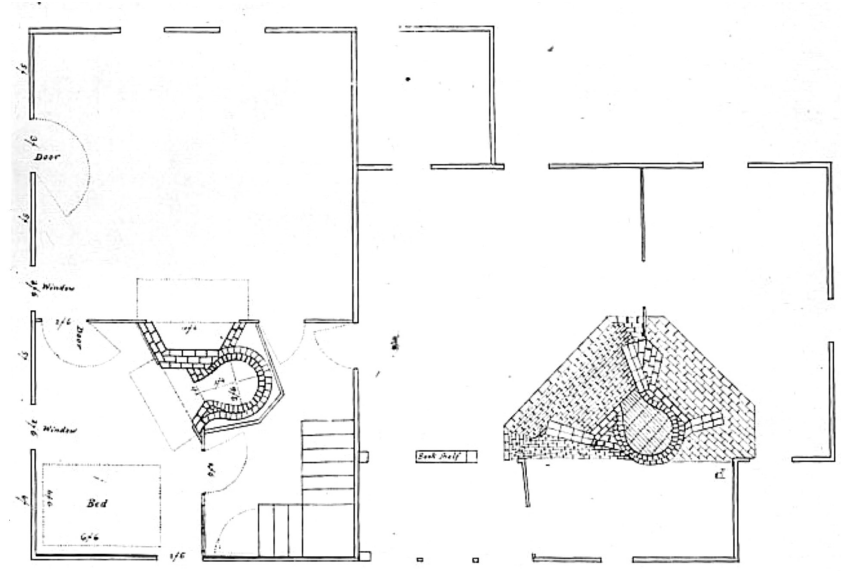
FIG. 2. FIRST (?) PRELIMINARY DRAWING BY JONATHAN FISHER FOR THE PLANNED ADDITION TO THE HOUSE BY JOHN WILSON CRANE - 1814

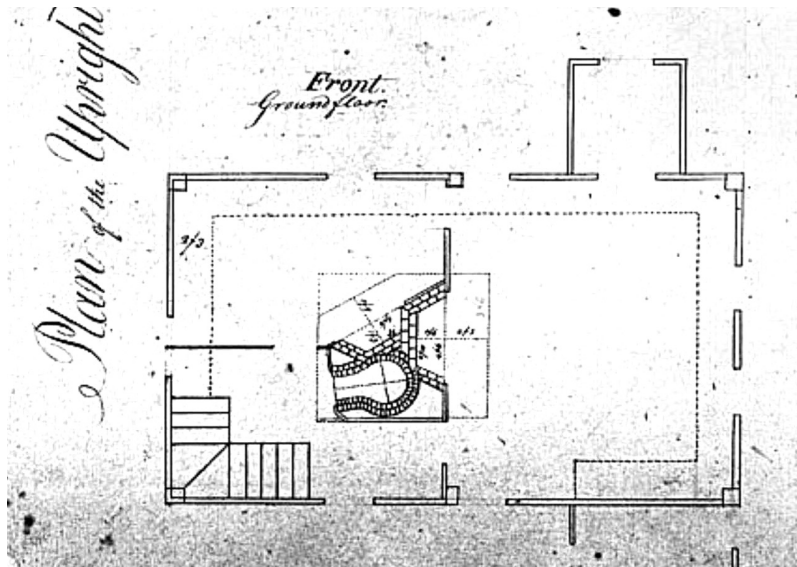
Jonathan Fisher's final plan for his new house, 1814. The door from the parlor into the existing house is clearly visible (right of center near bottom) and corresponds with the wall framing plan below. From Abbott Lowell Cummings article, 1966.

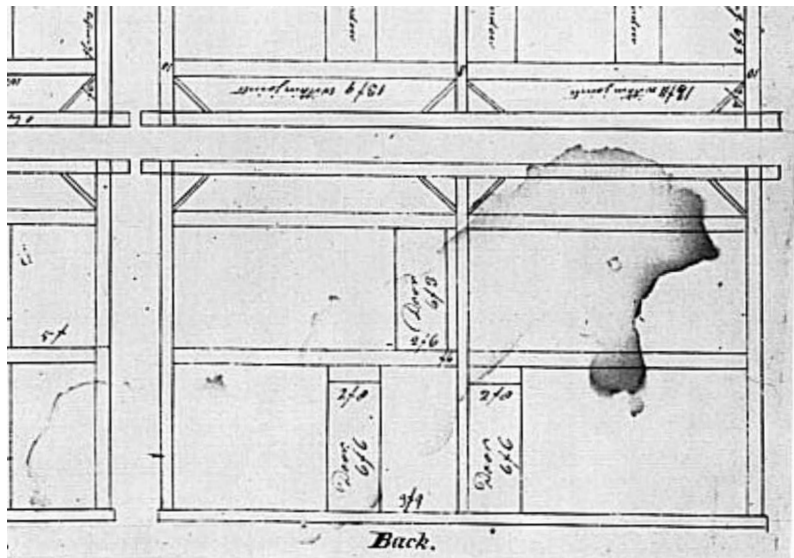
This framing plan for the back wall, drawn by Jonathan Fisher in 1814, clearly shows the two door openings from the new building into the existing house, which became an ell to the new structure. From Abbott Lowell Cummings article, 1966.

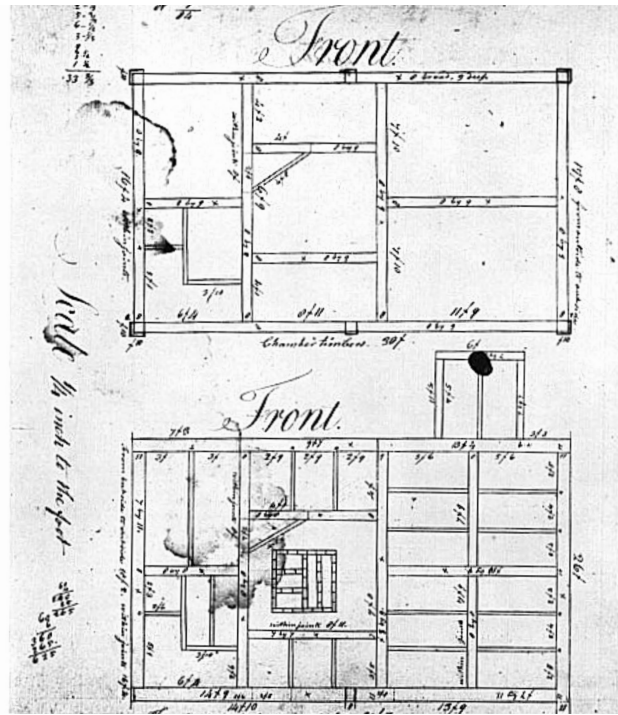
FIG. 5. DRAWING BY JONATHAN FISHER FOR THE FRAMING OF FIRST AND SECOND FLOORS OF THE PLANNED ADDITION TO HIS HOUSE IN BLUE HILL, MAINE, 1814

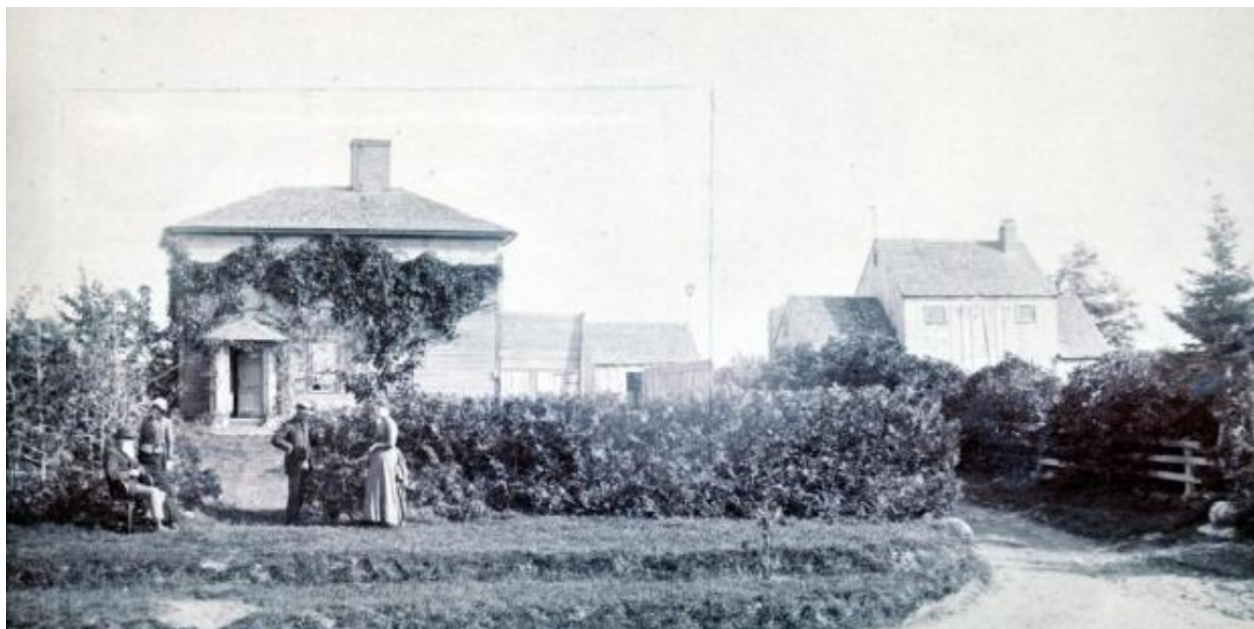
C. 1888 photo of the Jonathan Fisher House and out-buildings with descendants of Fisher posed by the road. Courtesy of the Jonathan Fisher Memorial Foundation.

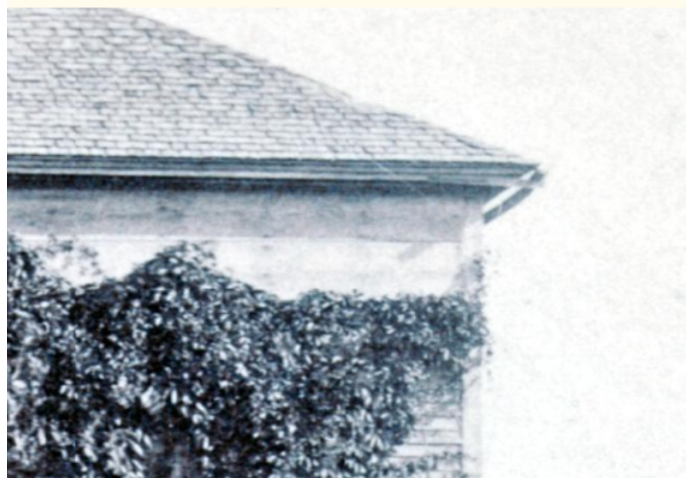
Detail from the c. 1888 photo of the Jonathan Fisher House, showing the metal gutters then installed at the eaves of the house. Courtesy of the Jonathan Fisher Memorial Foundation.

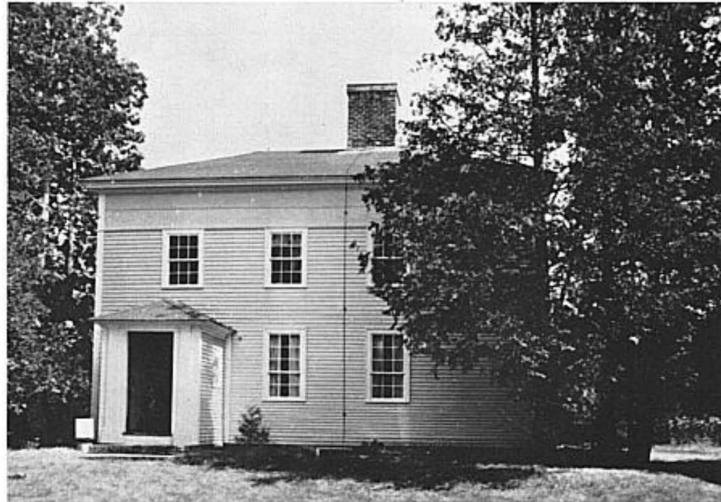
FIG. 10. JONATHAN FISHER HOUSE, BLUE HILL, MAINE, 1814  
Photo by Ward Snow, 1955.

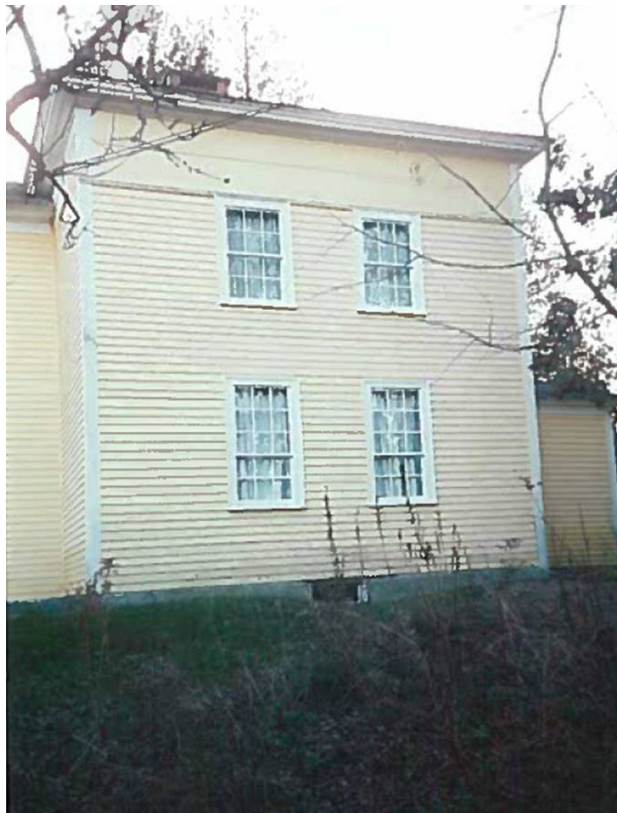
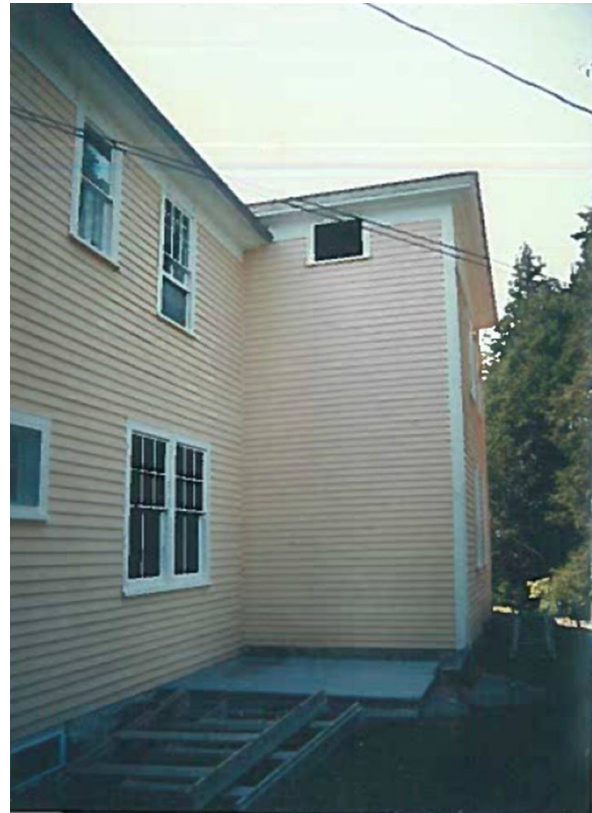
1990's views of the north and east elevations of the Fisher House showing exterior wall conditions at the time the last round of interior structural work was undertaken. Courtesy Jonathan Fisher Memorial Foundation.

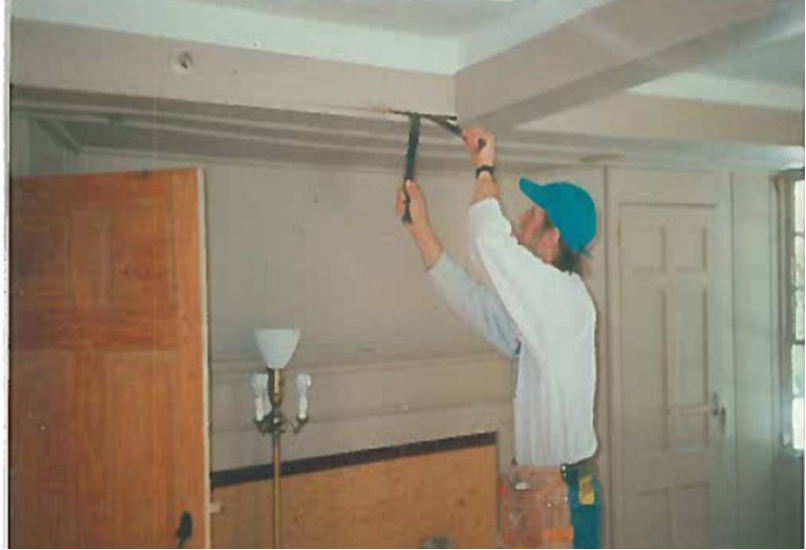
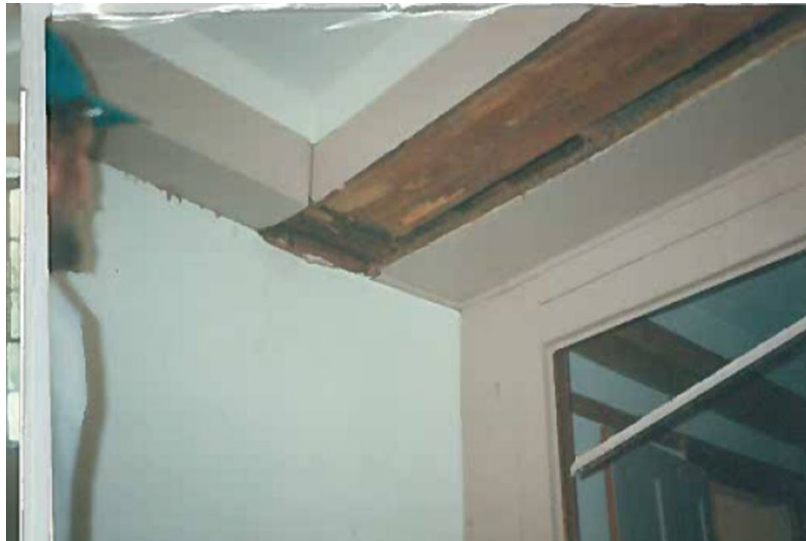
Workman removing trim boards to expose beams during 1990's structural repair work. Note areas of rot visible near juncture of beams. The beam currently in question is that at left.

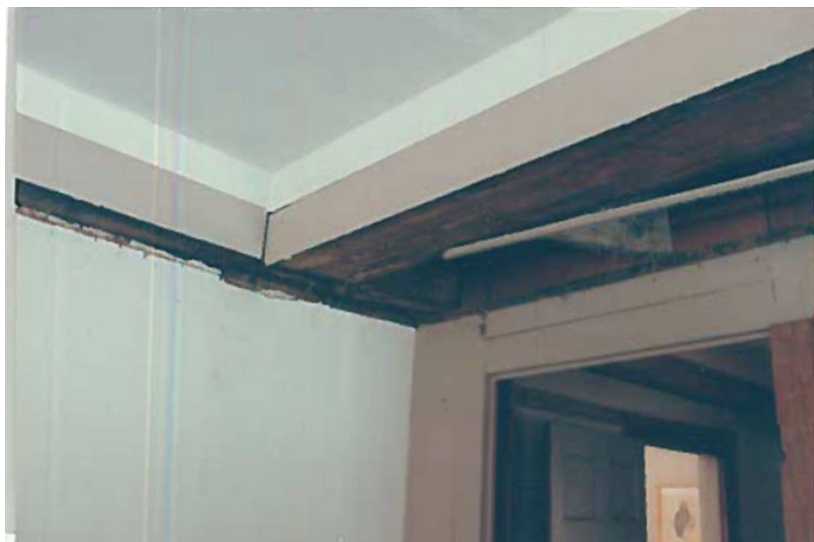
Exposed beams during 1990's structural repair work. Note that the girt at left is exposed on the bottom but not on the side. Only a small area of the top was exposed as well.

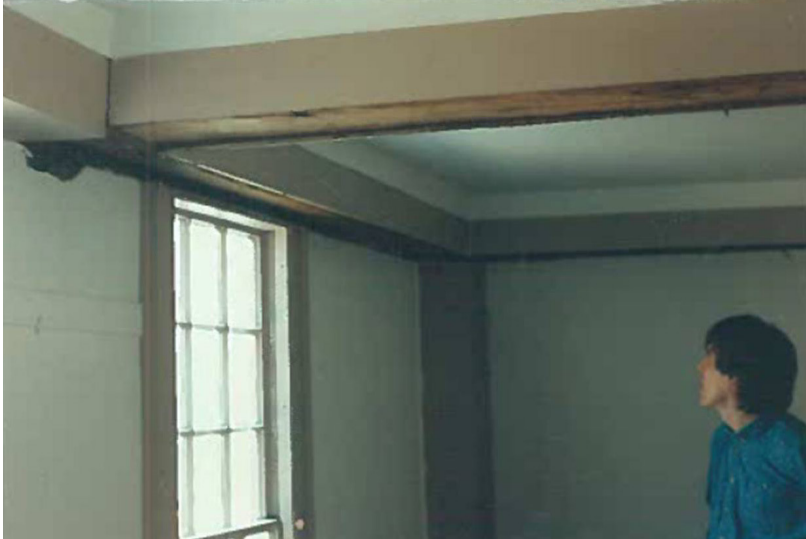
This 1990's view shows that only the bottoms of most of the beams were exposed, making it impossible to detect deterioration in the tops of the beams unless it extended all the way to the bottom.

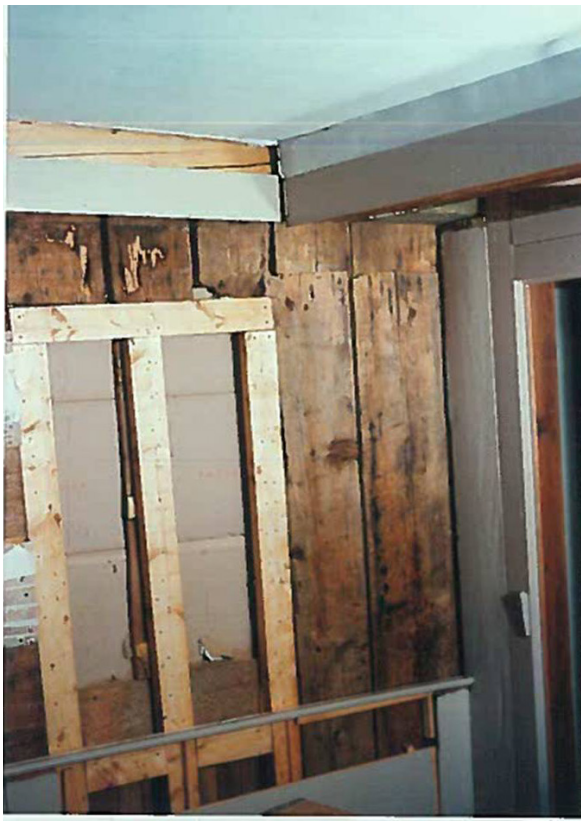
This 1990's view in the parlor shows the original door opening into the ell exposed.

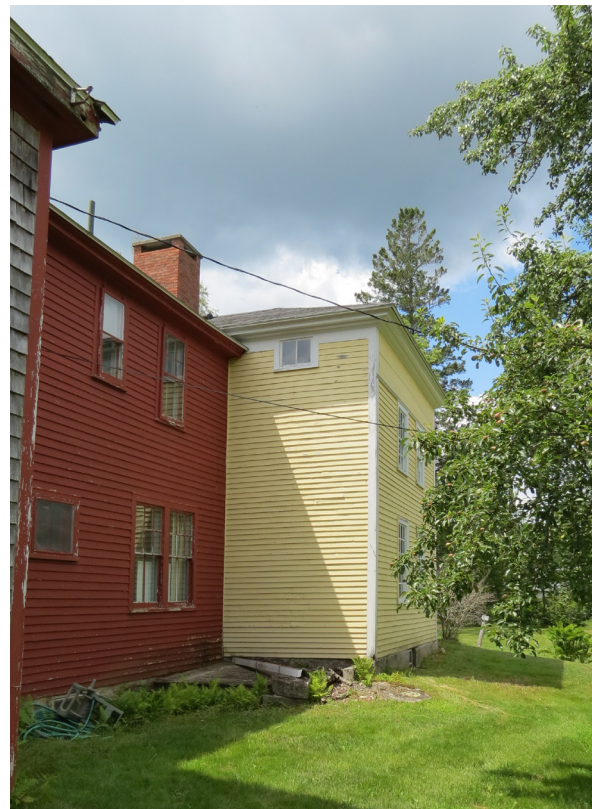
Current view of the northeast corner where the ell and house meet, not deteriorated paint on the 1814 house from water cascading off the ell roof. SCC, July 2019.

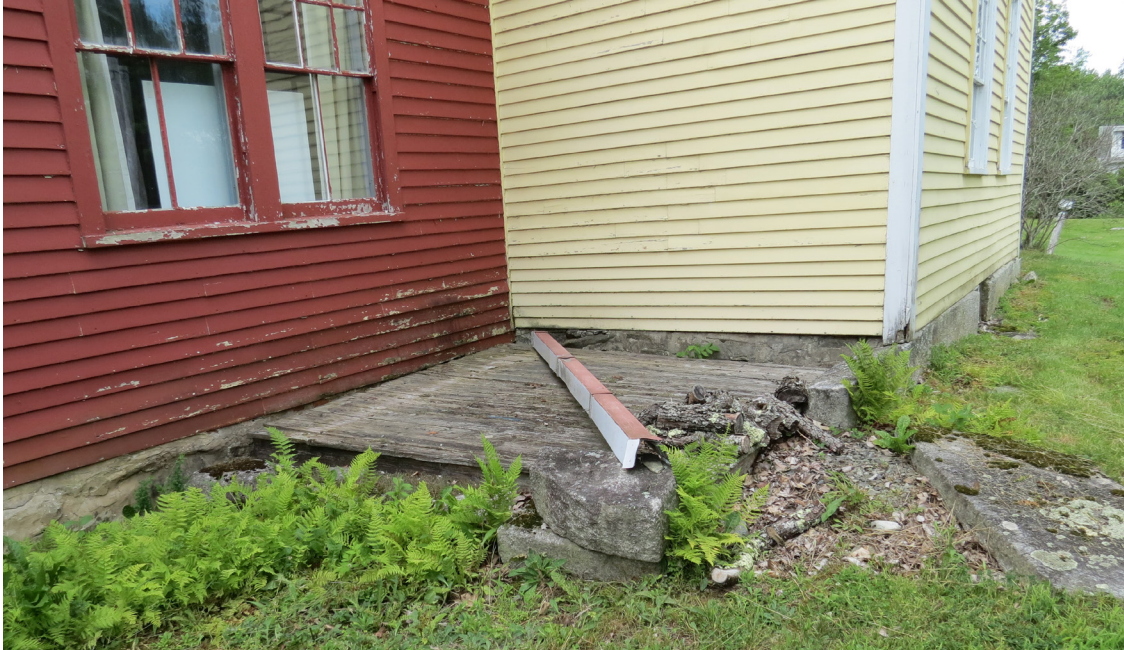
Current conditions in the northeast corner where the 1814 house (yellow) is joined by the 1896 ell (red). The buttery/cheese room built in 1814 stood where the wood platform is located. Note the fallen gutter, which was installed on the roof of the ell at some point after 1993. SCC, July 2019.

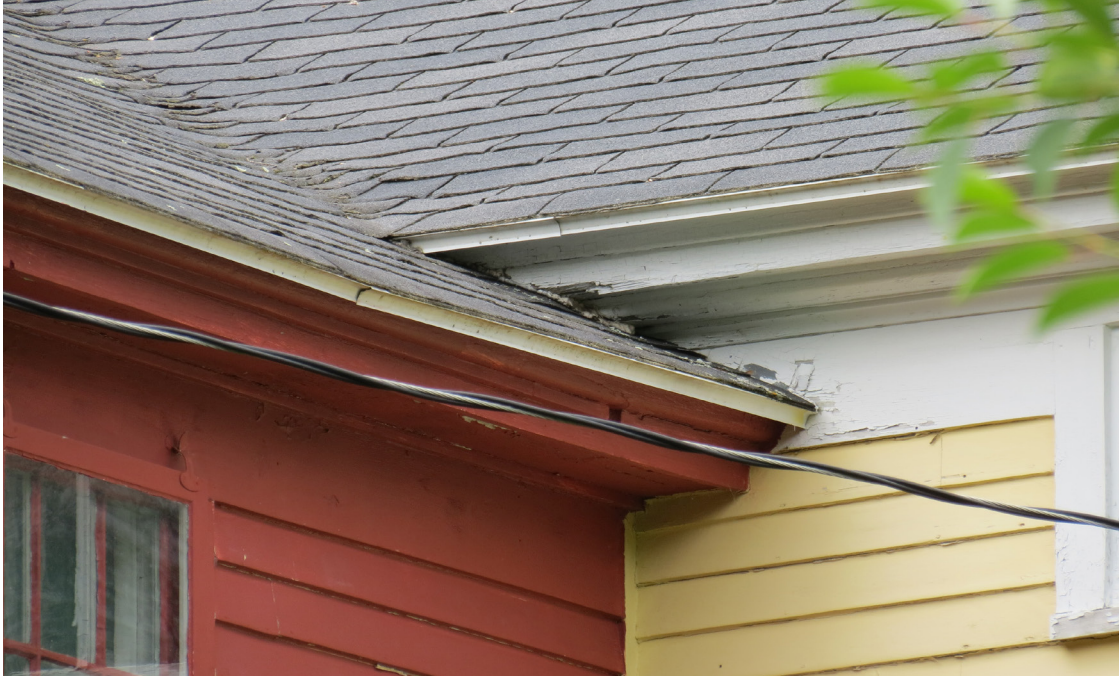
Detail view of the valley where the roofs of the two sections of the house meet. Water flowing down this valley and from the ell roof contribute significantly to the water issues on the rear wall of the 1814 house (yellow wall). A gutter previously installed here to mitigate the issue has fallen to the ground. SCC, July 2019.

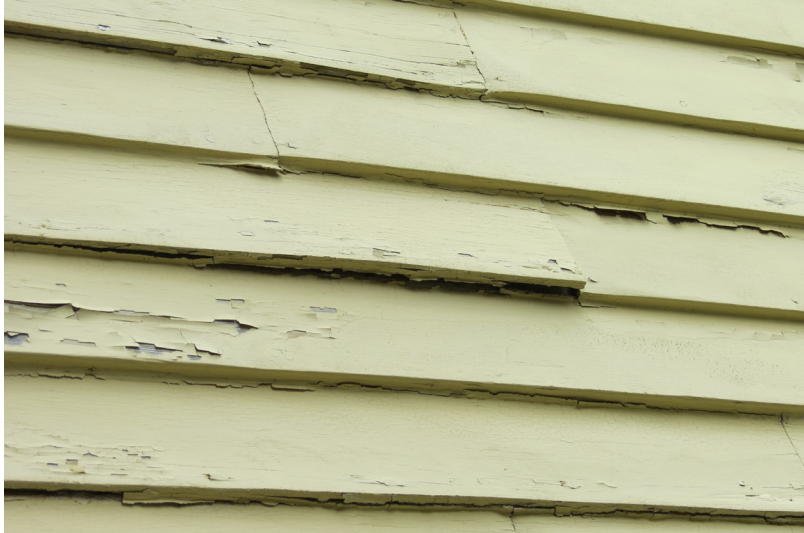
Detail view of failing paint and caulking and warping clapboard on the east (rear) wall of the 1814 house, near area with sagging floor. These conditions indicate prolonged exposure to excessive water, including moisture within the wall cavity. SCC, July 2019.

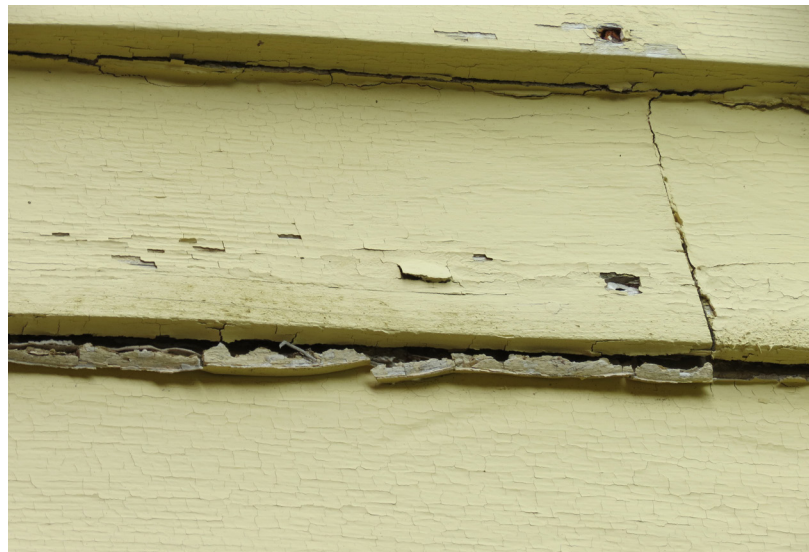
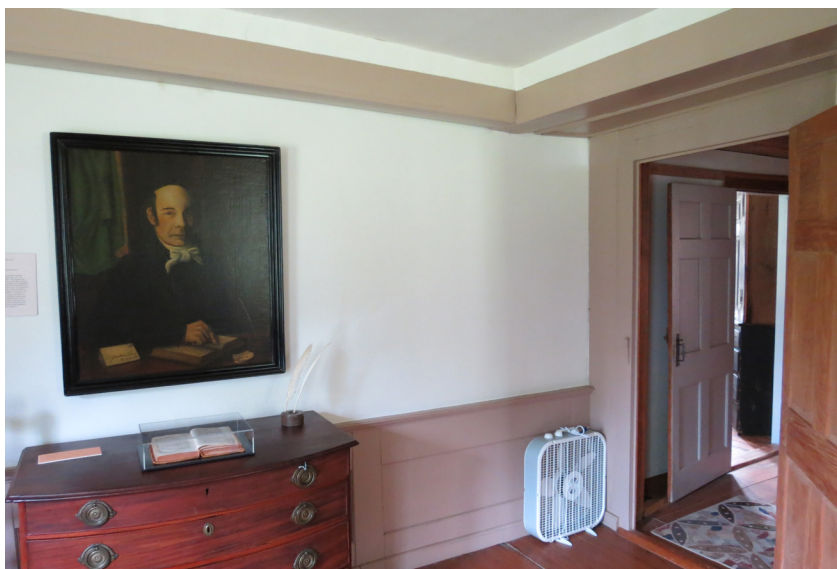
Current view in parlor of the area below the sagging floor. Wainscot and plaster adjacent to the door at right was installed to cover original door opening, apparently during 1950's restoration. SCC, July 2019.

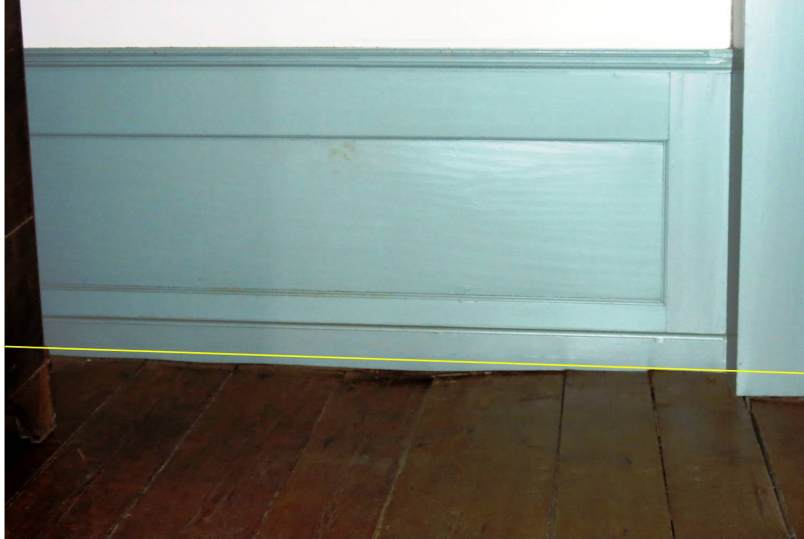
View of the sagging floor in the chamber over the parlor. The level yellow line has been added to help illustrate the extent of the sag. The location of the 1993 beam repair is at far right in the photo. Note that the baseboard was scribed to follow a sag that existed in 1993 and has now increased noticeably. SCC, July 2019.

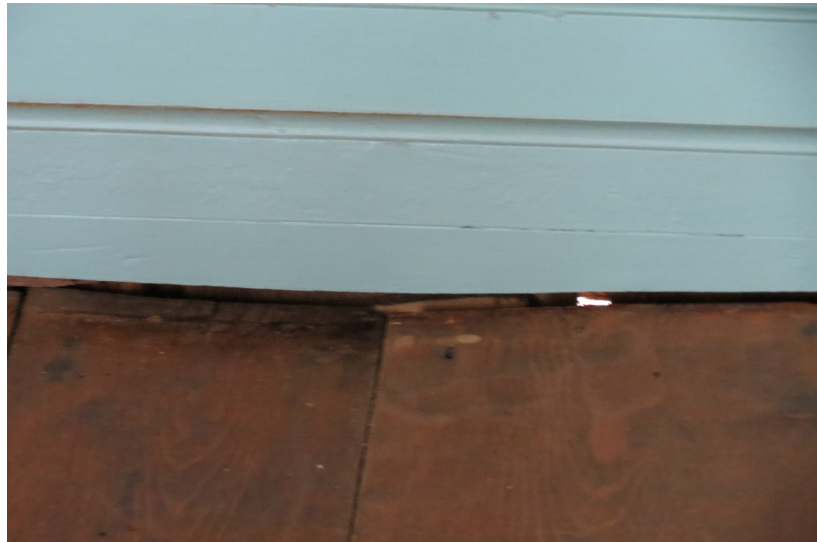
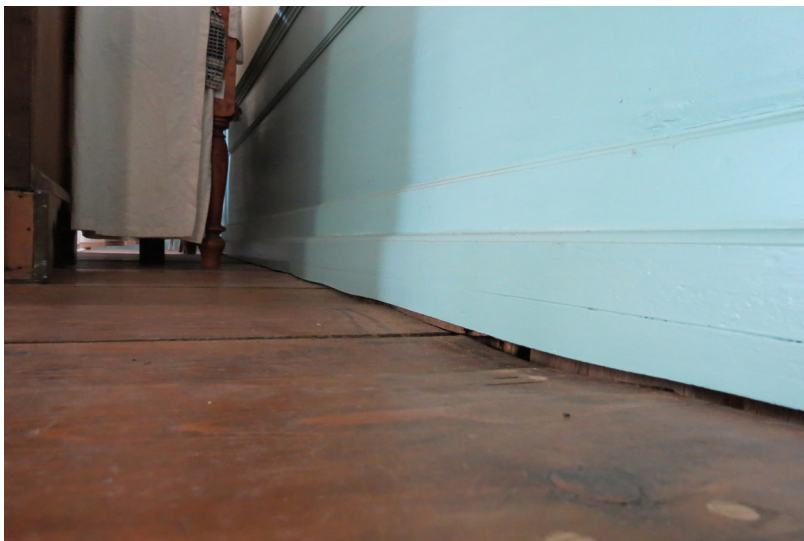
Another view of the sagging floor and previously altered baseboard. Note wood plugs in floorboard in foreground, which cover screws installed after the 1993 repairs. SCC, July 2019.
